## **Technical Support Bulletin**

### **Q3DTSB-2007-03-16**

# **IG Renderer(IGR4) Network Interface Connection**

**Issued 16 March 2007**

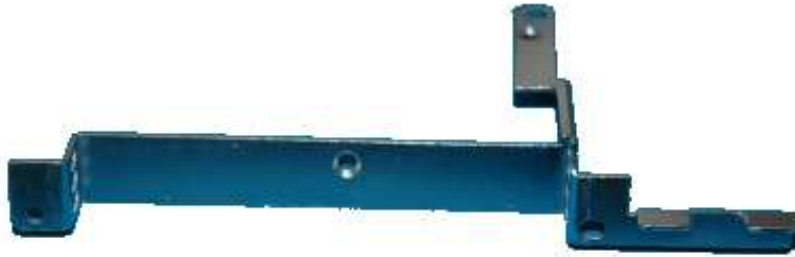
Figure 1, retention bracket

Description		
<p>As a result of manufacturing tolerances present in the main board of Independence 3000 (IDX3000) image generator renderers (IGR4), network connectivity can become compromised, especially depending on the type of Ethernet cable connector used in the Ethernet network interface. Although the manufacturing tolerances for the Ethernet parts are within expected range, the network connection may become intermittent or lost. This problem is often aggravated by shipment, movement of the system, or operating the rear door on the system when the previous Ethernet cable types were used which have a very rigid and larger connector 'head'. As a result of this finding, Quantum3D has decided to take corrective actions.</p>		
Product	Module	Model
Independence 3000	Network Interface Connector	IGR4
Operating Systems	BIOS	Driver
NA	NA	NA
Symptoms		
<p>Under certain situations the user of the IDX3000 may experience loss of synchronization while running Mantis, IG lockup, IG start up problems, or an IGR4 can appear to lock-up requiring a system reboot. The IGR4 may also appear offline to the IG Manager (IGM) software on the IGC which may cause loss of replication services.</p>

Fixes		
<p>The fix includes a cable retention bracket (see Figure 1) and new network cables (see Figure 2) for each IGR4. The fix will ensure that the network connection remains intact during shipping and normal operational use. This fix can only be provided by a Quantum3D Field Service Representative or factory approved technician as all of the new cables must be properly routed, wrapped and tied as shown in Figure 3 at each IGR4.</p>		
Work-A-Rounds		
N/A		N/A
<b>Scheduled Date Available:</b> March 21, 2007
